## Case History 546

### *Large Diameter Pipeline Rehabilitation*

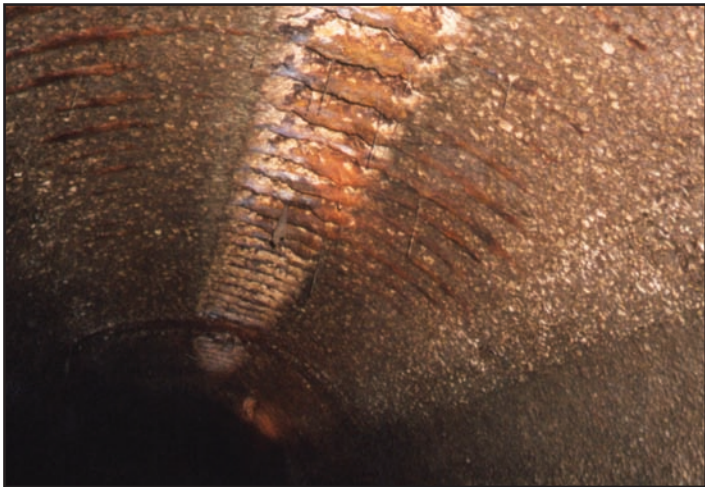
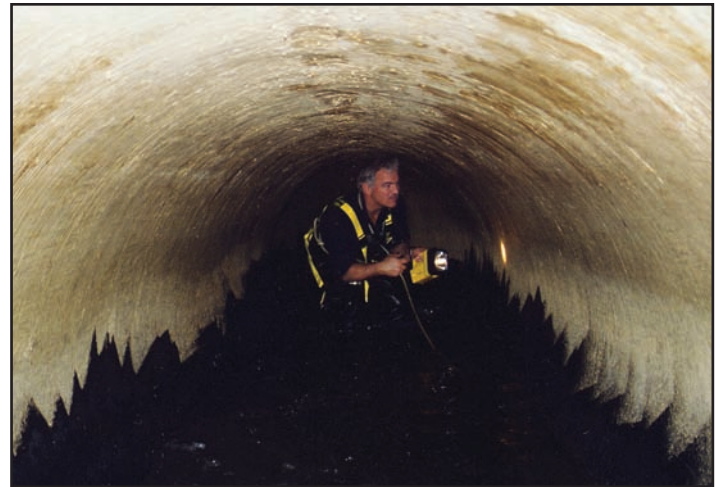
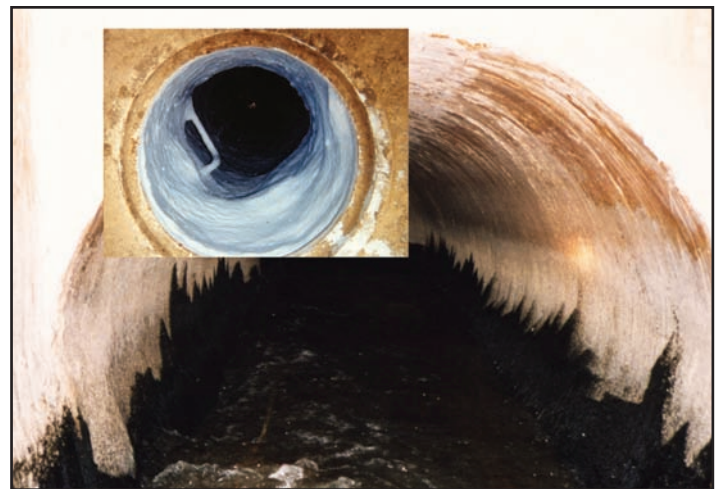
Severe MIC corrosion of 60" sewer interceptor in Miami-Dade. Crown of RCP corroded at more than 2" exposing corroded steel reinforcements. Interceptor rehabilitated with 80-300 mils of A-6 in 1996.

An 18-month inspection found the epoxy in excellent condition with no loss of bond or any sign of distress. Those involved in the inspection included Rod Lovett of Miami-Dade, Patrick Murray of Earth Tech Engineering, John Hoffman of Hazen & Sawyer, Stewart Nance of Raven Lining Systems and David Leyland of KTATator.

A-6 was found in mint condition in interceptor and specified for future sewer rehabilitation by Miami-Dade.
