## Case History 536

### *Bolted Steel Potable Water Storage Tank Rehabilitation and Corrosion Protection*

Owner: MUDD District 33

Location: Houston, TX

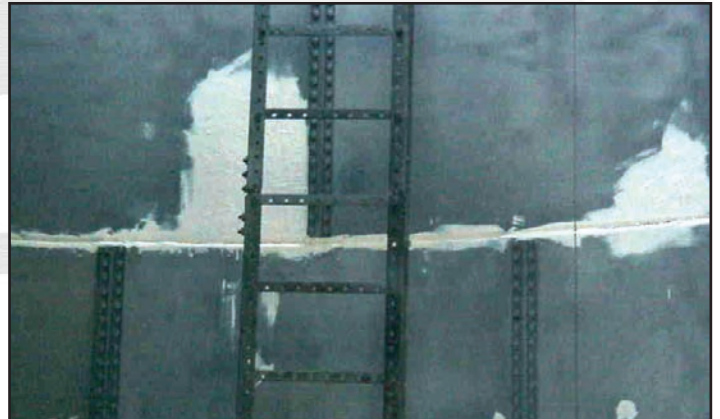
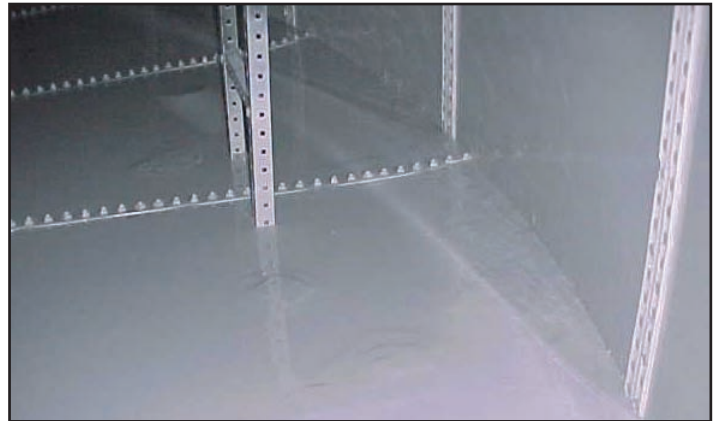
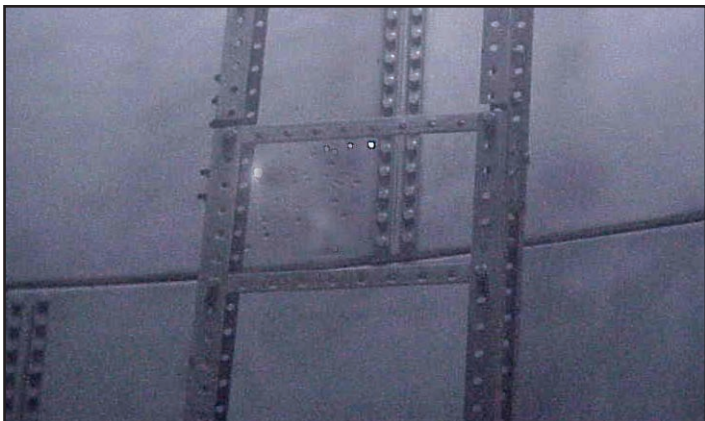
Bolted, galvanized steel, 250,000 gallon potable water tank. Condition before restoration included 72 holes in the shell, seam leaks and 124 holes in floor. Surface preparation of near white blast was performed. Following surface prep, large holes were patched with A-7 gel with fiberglass mesh inlaid. A-7 was also used to patch all remaining holes. Walls were coated with three coats of A-6 at 5-8 mils; total DFT of 16-24 mils; floor total DFT of 40 mils.

An inspection in 1999 revealed the tank to be in "as good as new" condition.
