Protective Coating Puts Stop to Headworks Corrosion

The Fresno/Clovis Regional Wastewater Reclamation Facility provides wastewater treatment and disposal for 97 percent of the 520,000 population in the Fresno-Clovis Metropolitan Area, one of the fastest growing communities in California. The 1700 acre property located southwest of Fresno originated in 1891 as a 40-acre disposal area. In the years that followed, the wastewater system successfully evolved through a series of expansions to respond to the needs of a growing population and to comply with increasingly stringent discharge requirements.

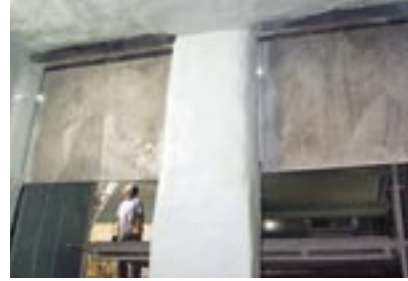
Completed structure after application of 125 mils of Raven 400S 100% solids epoxy coating.

The city specified the entire structure to receive 125 mils (3 millimeters) of Raven 400S. In more heavily deteriorated areas, a base coating consisting of Quadex Aluminaliner, a fiber-reinforced, 100% calcium aluminate aggregate enhanced mortar, was first applied from one to two inches thick as necessary to rebuild severely deteriorated surfaces. Calcium aluminates are high early strength specialty cements resistant to corrosion. Approximately one third of the structures required this composite solution. Raven 400s was then applied after the cementitious basecoat had cured at least 24 hours.

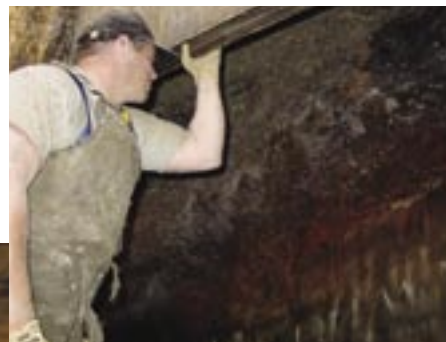
A crew from F&L Concrete Services spray-applies the new coating to protect concrete surfaces from corrosion.

F & L used Raven's proprietary plural component spray application system to ensure a uniform ratio and thickness throughout. Although the epoxy could be applied to a 125 mil thickness in one coat, it was done in two coats to ensure higher quality. Good coating practice suggests that defects inevitable in single coat systems can be encapsulated in a two coat system. A wet film thickness gauge was used systematically throughout the application to ensure uniform coating thickness.
