Case History 538

New York Aqueduct Gets Its First Fix in 125 Years

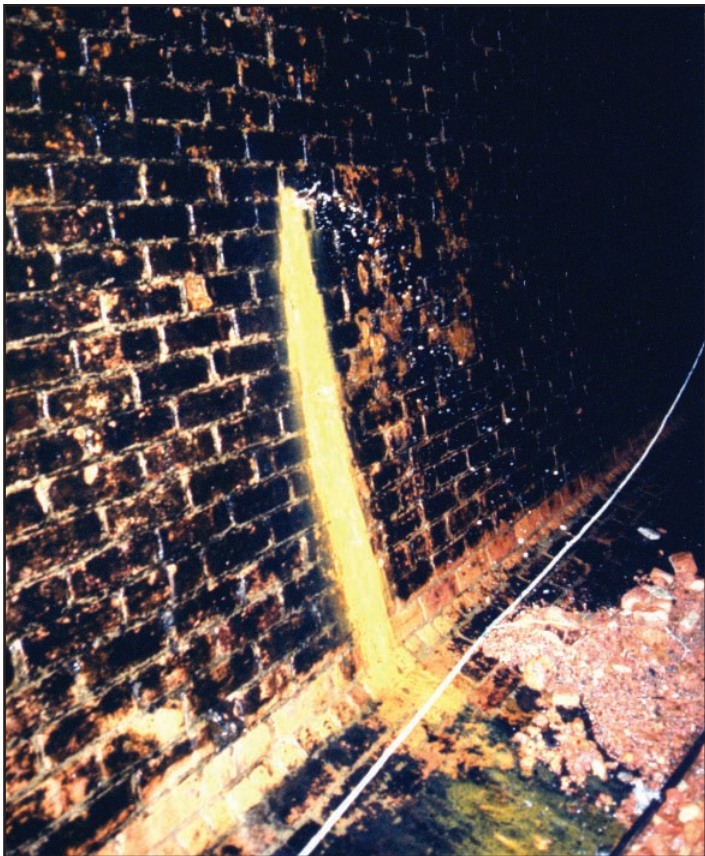
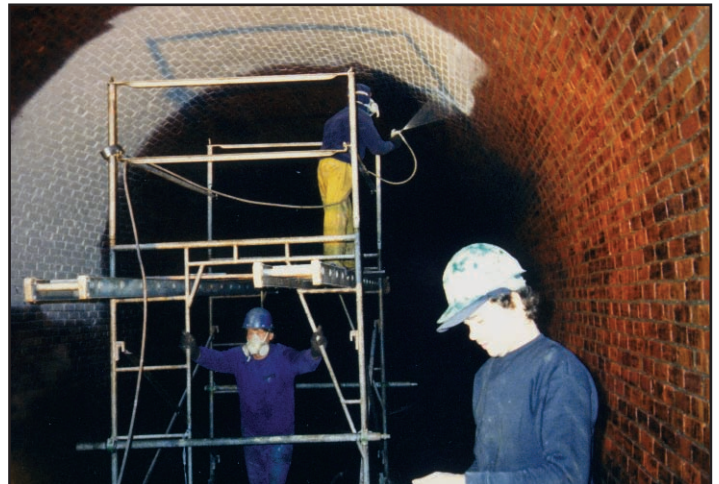
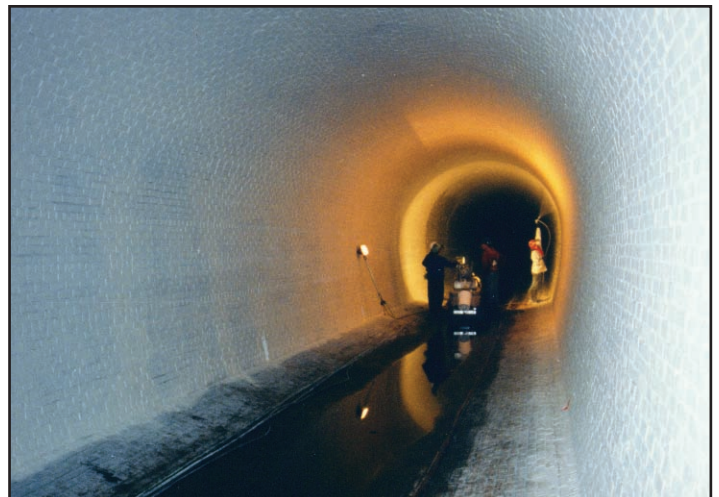
In 1996, Raven's AquataPoxy A-6 was specified for a 1,000-foot long test section of the New Croton aqueduct. High pressure water blasting was performed to clean the brick and remove remaining unsound surfaces of calcium buildup, brick and mortar. A-6 was then spray-applied to 30 mils. A-6 exhibited superior bond strength and delivered structural reinforcement to the old brick. A two year inspection of the test section revealed A-6 still in mint condition ... perfectly bonded and undamaged.
