## Case History 547

### *Power Plant Tank Lining*

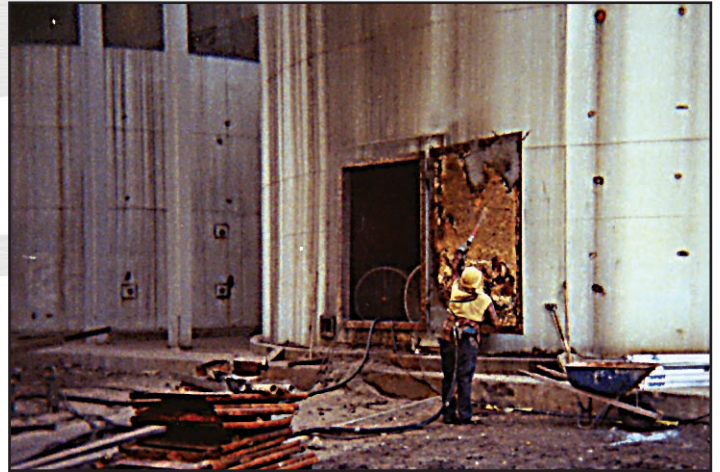
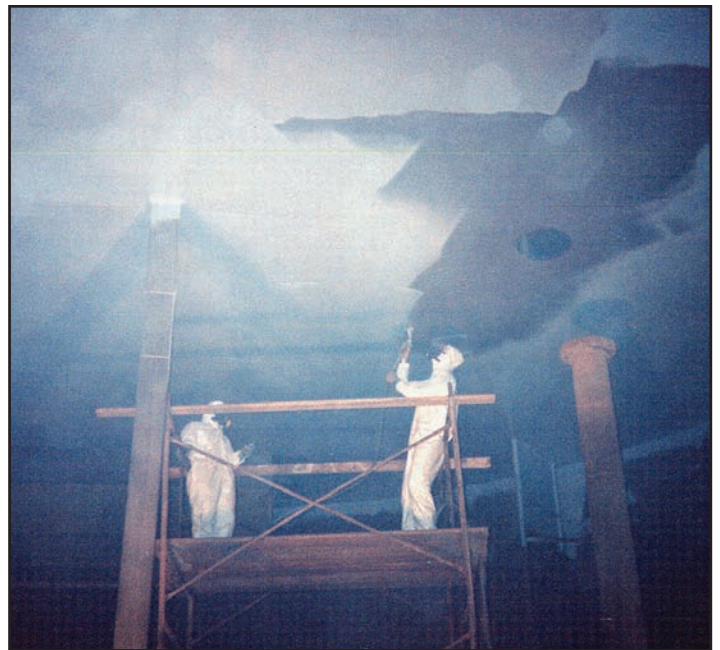
The largest coal fired electric generating facility in the state of Kansas was faced with a decision to rehabilitate or replace its eight 46' diameter by 21' deep scrubber tanks in 1993. The steel tanks contained 10% limestone slurry for cleaning coal exhaust. The tanks were experiencing structural failure due to abrasion from the limestone slurry and accelerated corrosion resulting from 185°F 10% slurry and captured sulphur dioxide. The 3/8" steel walls had numerous leaks from corrosion, the worst of which resulted in large welded patches to compensate for surrounding weak and thin areas. Previous coatings had been moderately successful in preventing corrosion but required multiple coats with narrow windows of time, weather conditions, recoatability, etc. The only remaining alternative was to line the tanks with stainless steel.

The tanks were rehabilitated the using Raven 405, a 100% solids ultra high build epoxy. Surface preparation consisted of sandblasting the interior surfaces to SSPC-10 specification. An ultrasonic thickness gauge was utilized to scan the sandblasted surfaces for structurally deficient thin spots (less than 50% of the original 3/8" thickness). Areas identified for "patchwork" received a structural epoxy patch consisting of a 60 mil tack coat of Raven 405 inlaid with 18 oz/yd<sup>2</sup> fiberglass woven roving fabric. The structural repair areas and remaining tank surfaces were then lined with a monolithic 75 mil single coat of Raven 405, at a rate of approximately 800 sq. ft. per hour in high humidity conditions. Five tanks (5,000 sf each) were turnkey prepared, structurally patched, lined, spark tested for holidays and pinholes, then touched up in 10 working days.

This project was performed in the summer of 1993. The tanks were inspected one year later and required minimal patching around welds, joints, and areas where mechanical damage had occurred. Patching was simply performed by cleaning and lightly abrading designated areas, then brush applying Raven 405. Raven has outperformed all other coating systems used to date, and the client has specified Raven's coatings for future work.
