## Case History 556

### *New Lift Station Receives Protective Coating Prior to Service*

Owner: City of Sand Springs  
Location: Lost City Lift Station  
Date: August, 1994

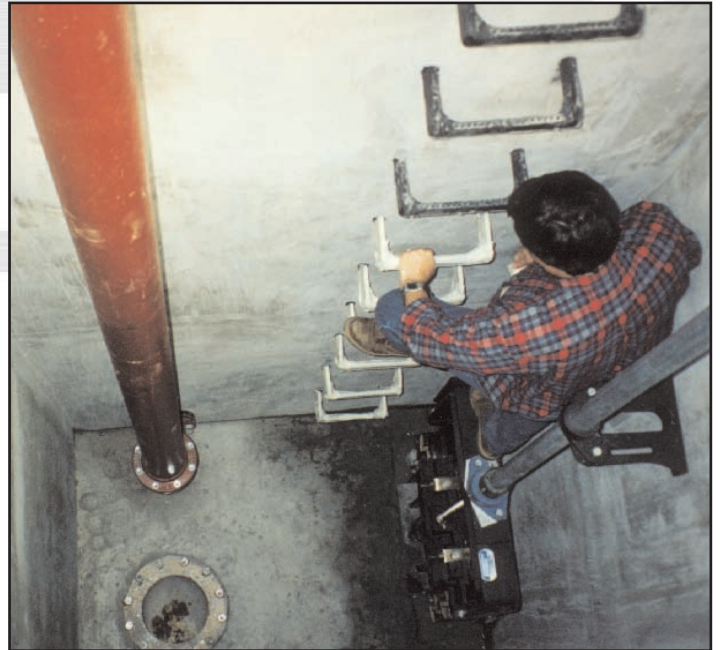
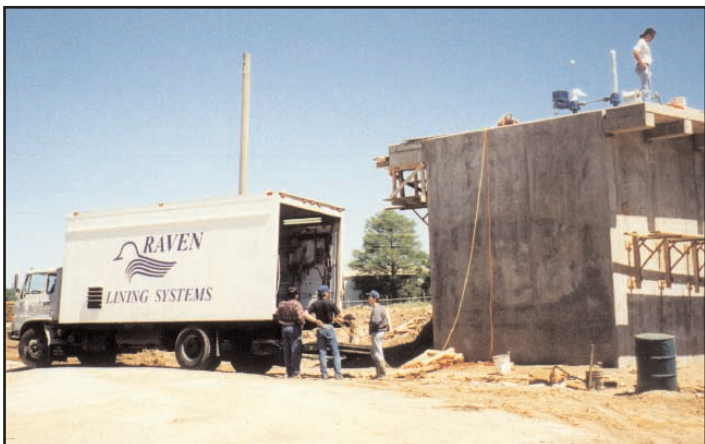
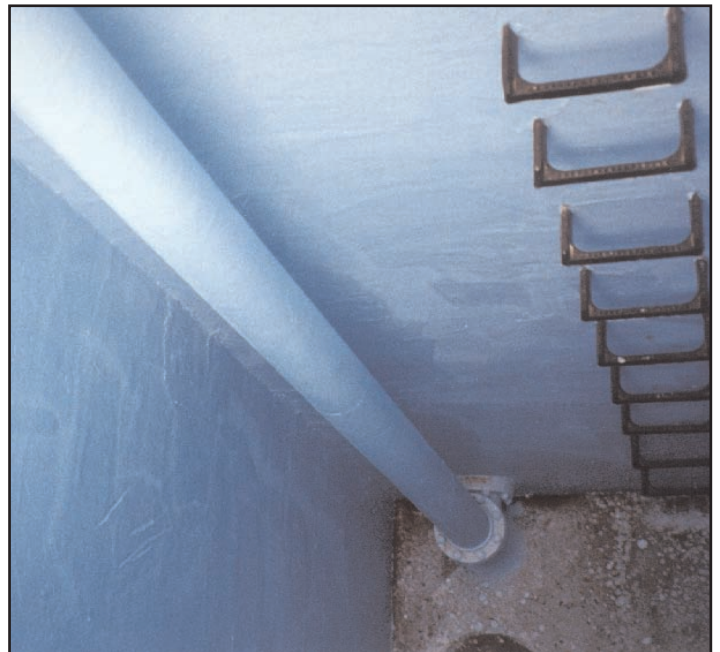
A new lift station was designed to receive Raven 405 protective coating prior to being placed in service. Raven 405 was applied to a DFT of 60 mils to prepared surfaces. Holiday detection was used to ensure the integrity of monolithic protection.
