Case History 550

Phoenix Manhole Rehabilitation and Corrosion Protection

Owner: City of Phoenix, NV
Location: 35th Avenue and Vogel
Date: November, 1998
Contact: Ray Ryan, City of Phoenix

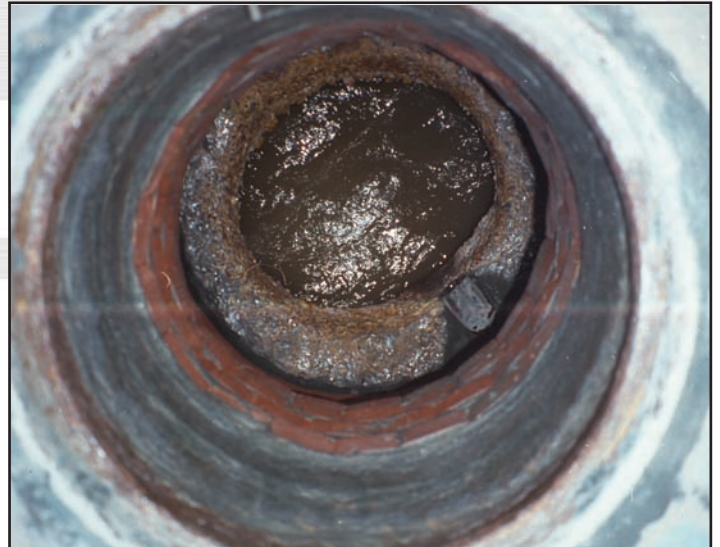
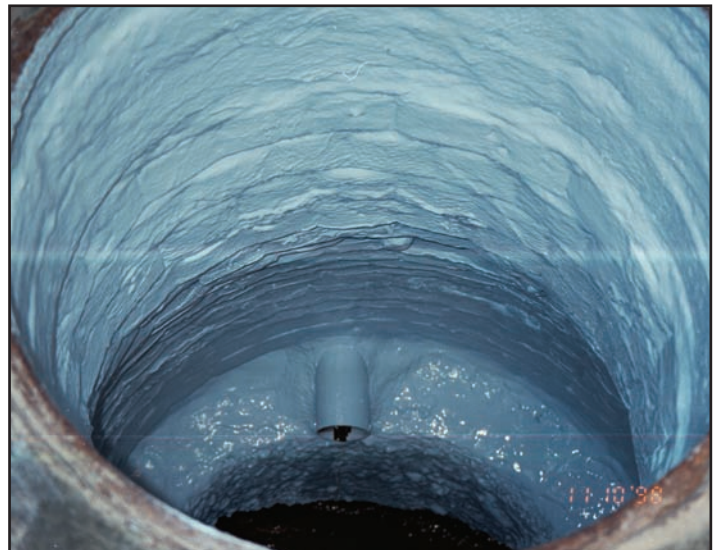
Structure: 11' deep, 4' diameter manhole with precast and brick walls. Bench completely deteriorated.

Corrosion: Severe

Rehabilitation and Protection: The manhole was cleaned using high pressure water cleaning at 5,000 psi, 4 gpm to remove failed portland cement and prepare brick surfaces to a clean sound substrate: 2" - 3" of severely corroded concrete was removed. After Mr. Ryan's inspection, the rough aggregate was lined with 125 mils of Raven 405 in order to evaluate the effectiveness of the coating to protect the structure. Upon completion of coating, the structure was holiday tested.

Approximately one year later Bob Webb and Karl Anderson were present for a follow-up inspection. No problems were identified with the product or process at that time.
