Case History 558

Brick Manhole Structural Enhancement and Corrosion Protection

Owner: City of Charleston
Location: 11th and Grove Street
Date: August, 1998

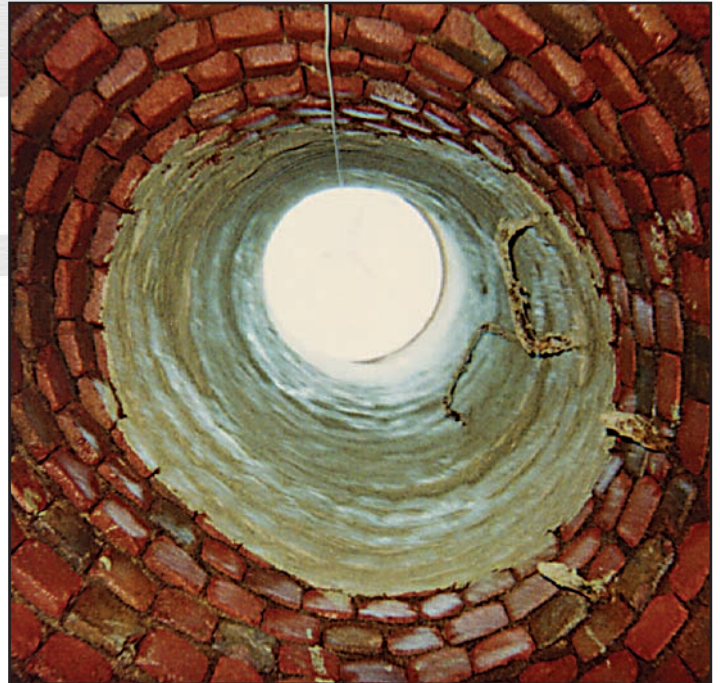
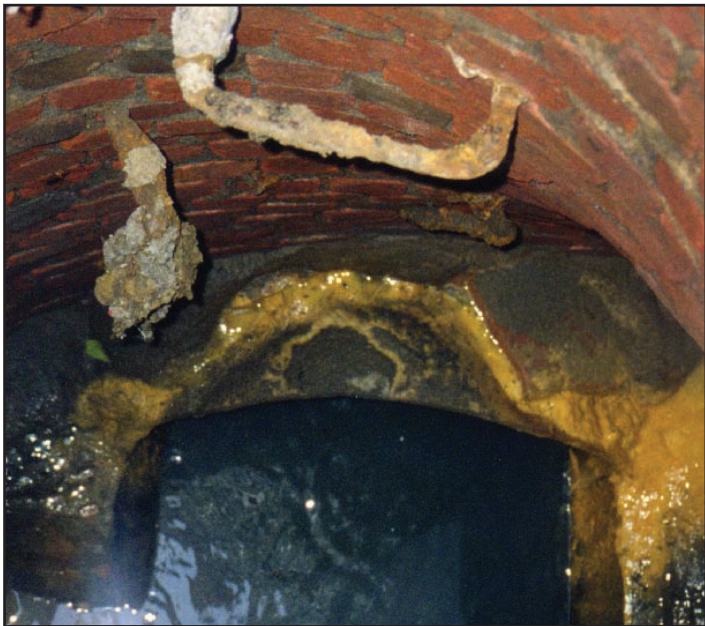
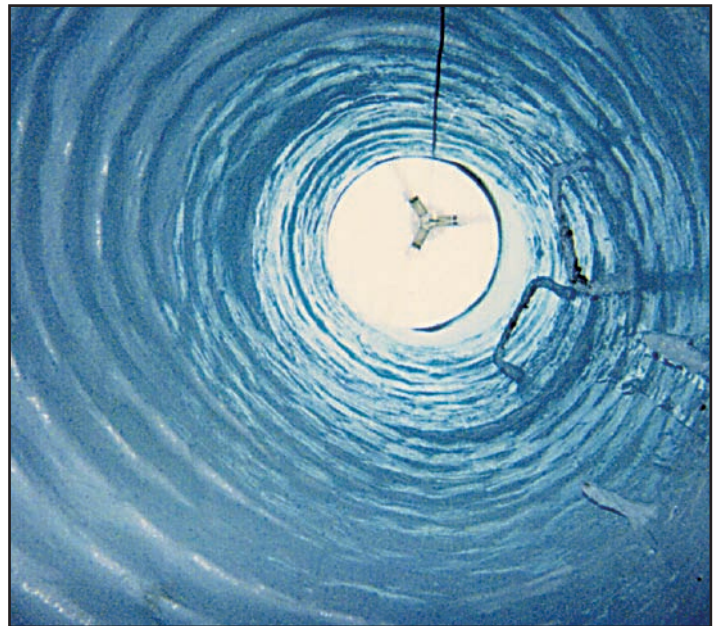
Brick manhole 15' deep, 4' diameter, with 30" CIPP rehabbed line and 10" dead line. Pipe joint leaking, bench severely eroded with voids. Rehabilitate and coat to low flow... unable to divert or plug lines. Hydraulic cement was used to fill large voids where mortar missing 1/2" and greater. The bench was rebuilt, voids filled and chemical grouts were injected up to 2' into the annular spaces surrounding the CIPP line where infiltration was visible. Raven 405 was applied at minimum of 125 mils providing structural enhancement and corrosion protection.
