## Case History 548

### *Wastewater Pipeline Rehabilitation and Protection*

Location: Cottage Grove, IL  
Date: 1994

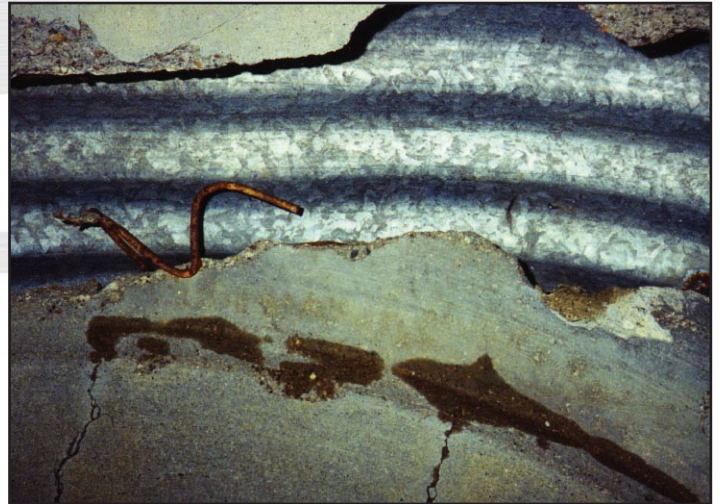
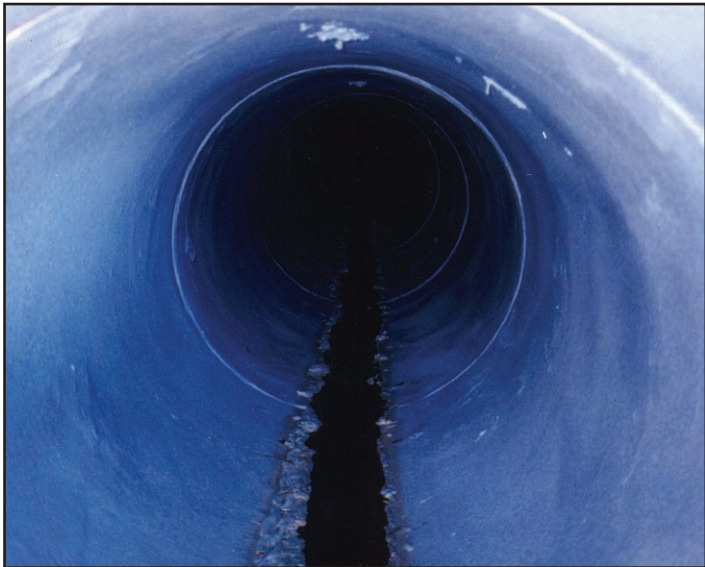
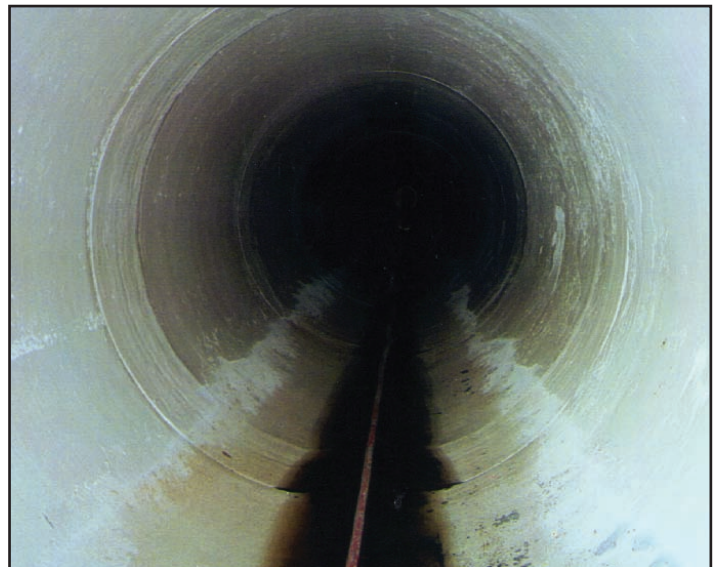
305 linear feet of 36" RCP storm sewer with 3' average overlay. The pipe was in good condition except for some installation damage and minor infiltration at the joints.

Structural damage was repaired with Raven structural epoxy grouts and the remainder of the pipe was coated with 80 mils of Raven 405 to prevent infiltration and protect the concrete from abrasion.
