Case History 531

Rehabilitation and Protection Concrete Potable Water Storage Tank Duluth Woodland Reservoir

Location: Duluth, MN
Date: September, 2000

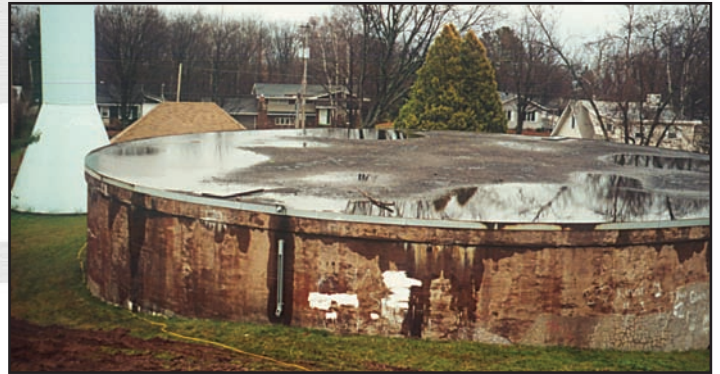
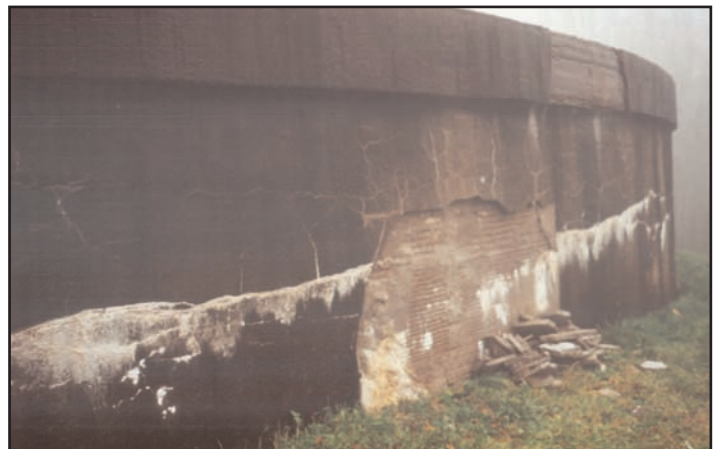
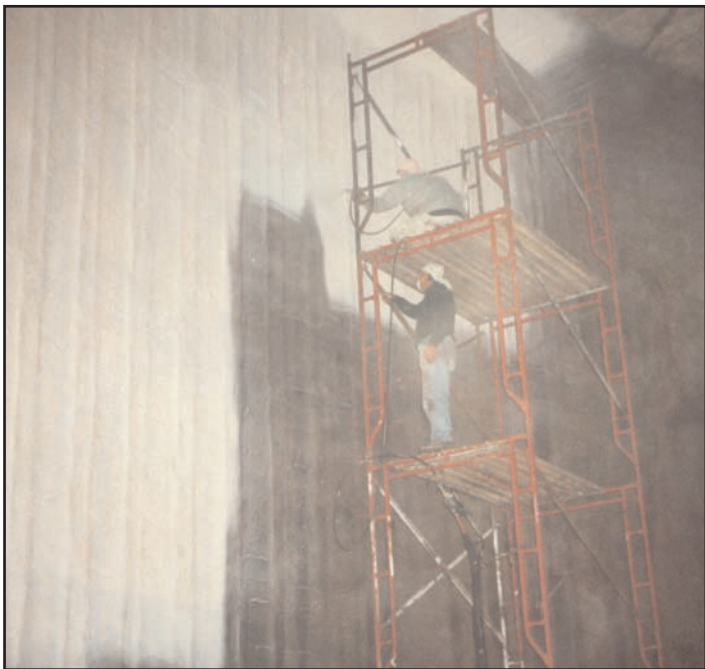
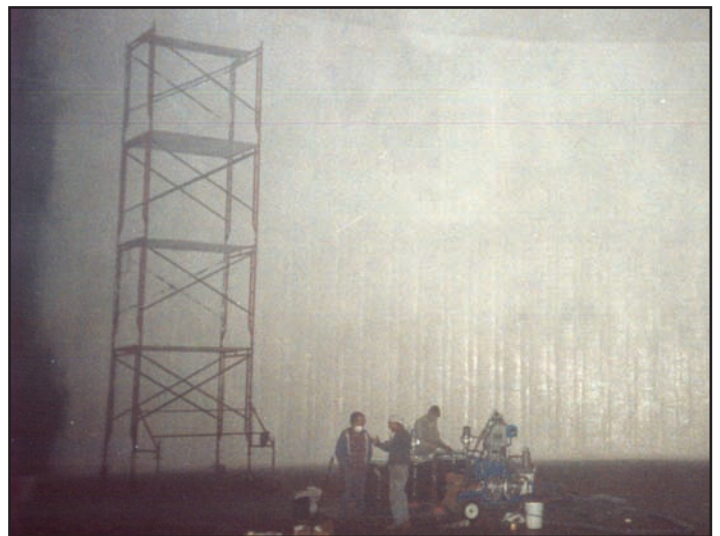
Rehabilitation and protection of Woodland Reservoir No. 2, a two million gallon concrete ground reservoir located in Duluth, MN.

Following surface preparation, repairs were made with A-7 grout. An initial coat of 8-10 mils, followed by two additional coats of 15 mils of Raven's AquataPoxy A-6 was applied.

Raven's A-6 coating has provided improved water quality, while extending the life of the tank for many years.
