Case History 540

Concrete Potable Water Storage Tank

Owner: Country of Kauai
Location: Lihue, Kauai
Date: July, 1999
Crew: Certified Applicator

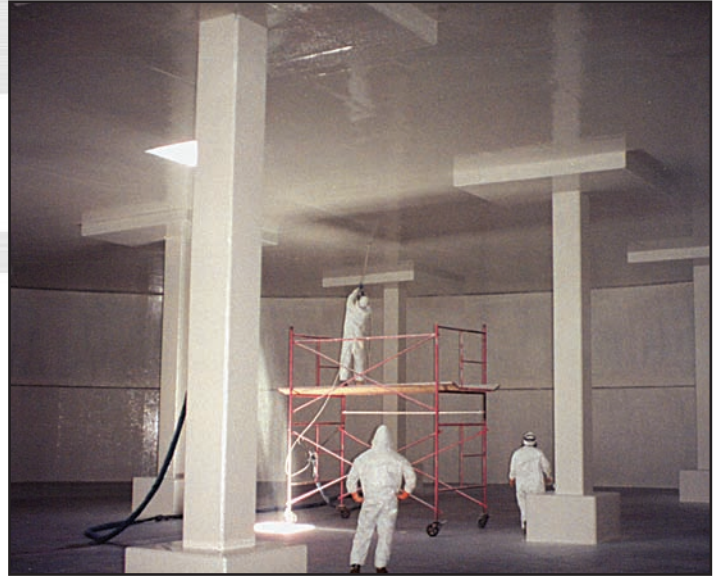
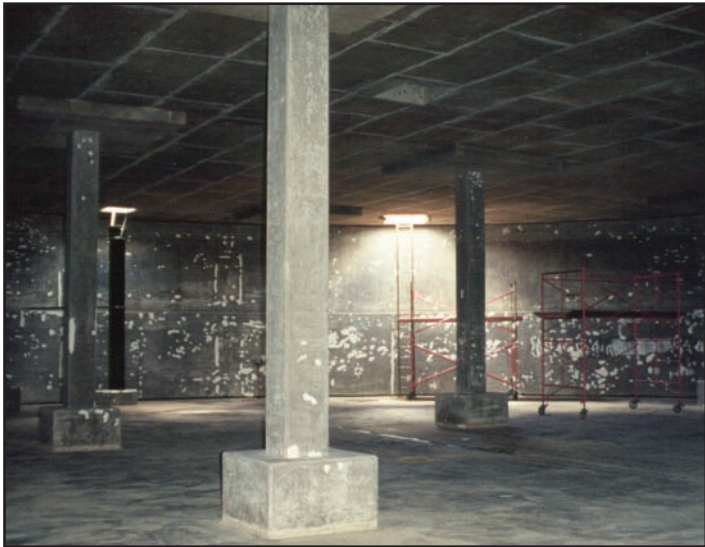
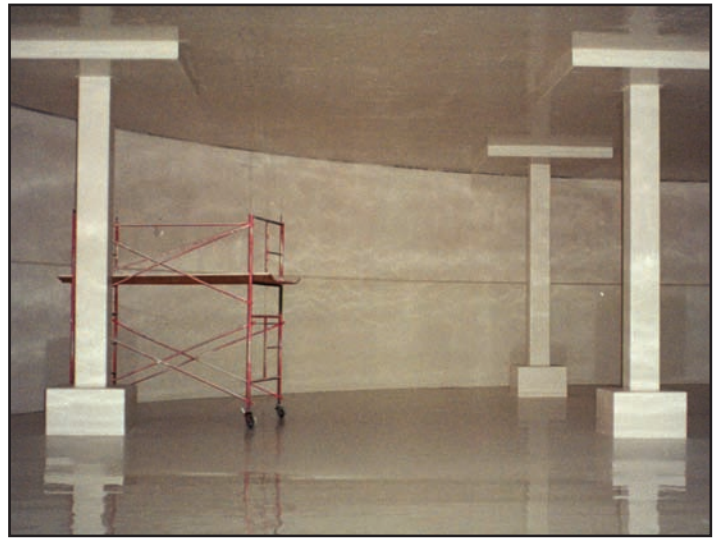
New 1.5 million gallon potable water concrete storage tank. Surface was prepared with high-pressure water cleaning. Bugholes were filled with A-7 grout. An initial coat of 5-8 mils of A-6 was applied, followed by three coats of 12-15 mils.

Total DFT 40-50 mils of A-6 is providing improved water quality, while extending the life of the tank by many years.
